Sample Report

Thermal Imaging Report

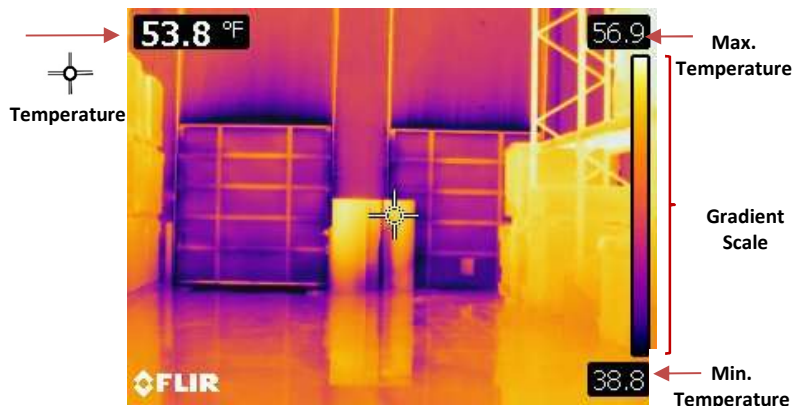
The darker color is cooler air coming into the building from the outside.

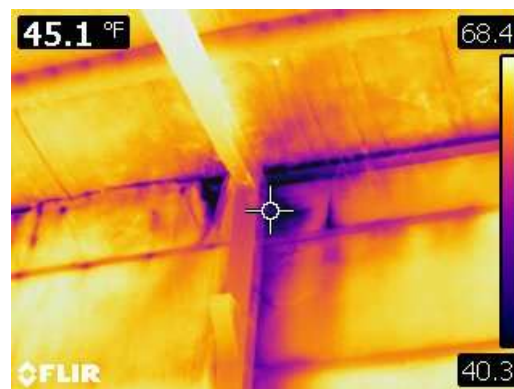
There is air coming in through the seam between the roof and wall materials.

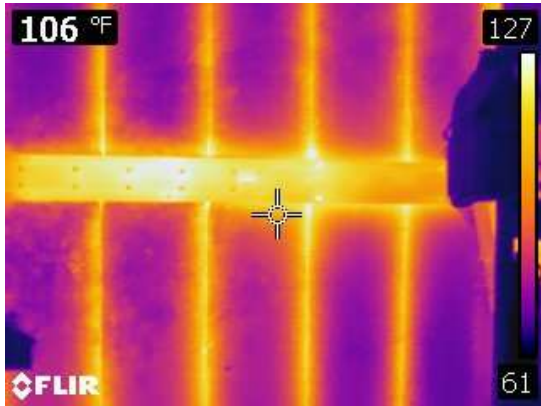
The seams of oven doors are far less insulated than the rest of the door.

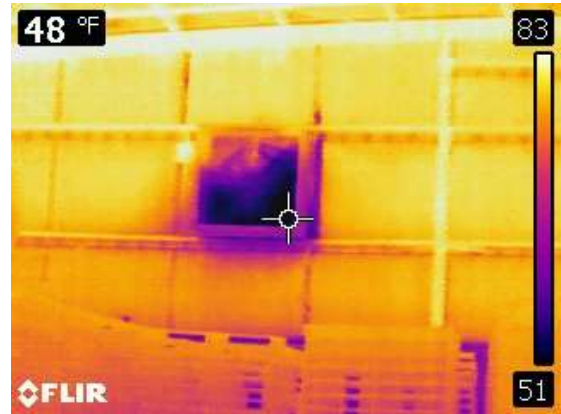
The cold outdoor air comes through wall penetration points.

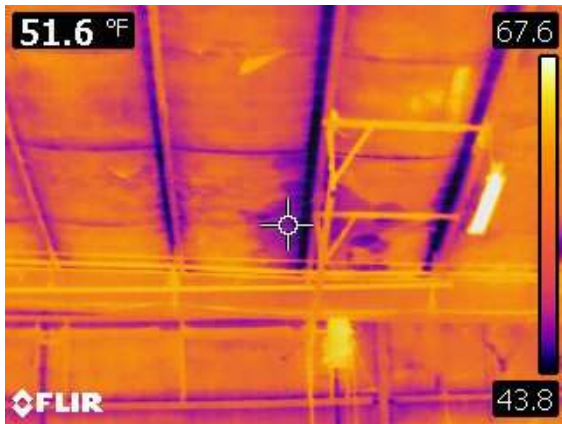
The darkness in the underside of the roof shows a wet spot and could point to roof insulation issues. These issues were seen in ██████████

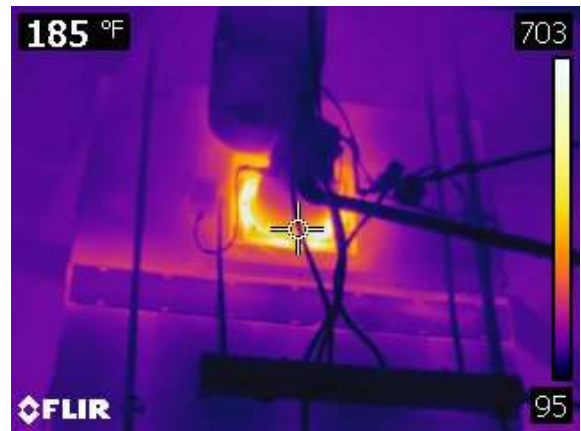
The main points of heat loss are on the back side of the ovens. Both upper and lower access points have high heat levels.

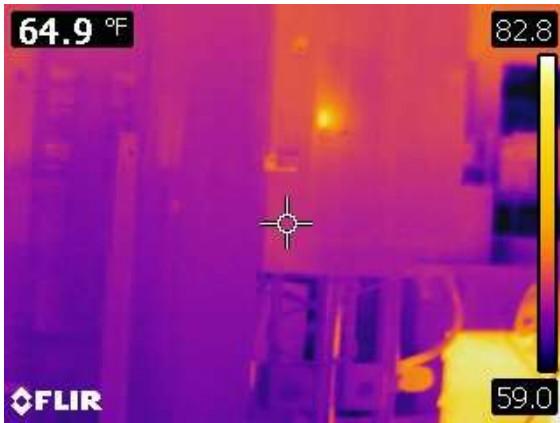
The bright breaker is more loaded than the others, but the 82F is not a concern. If breakers are above 120F, they should be investigated further.

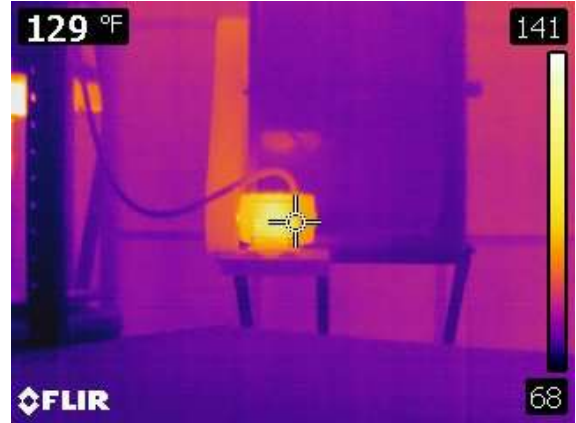
The motor having the exterior temperature show over 130F means the inside is even warmer. This could be a sign the motor is toward end of life, or be slipping.

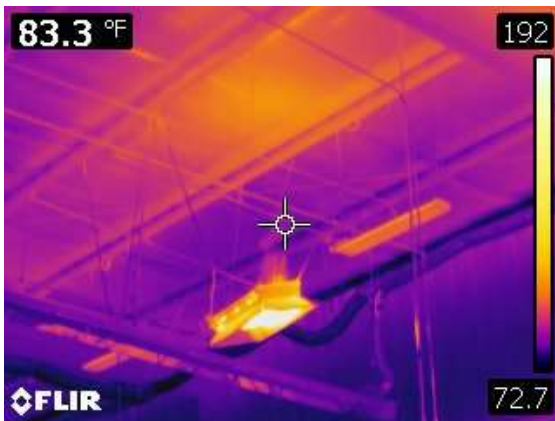
The heating unit above the foaming area is on and generating heat. There are a number of areas in the facilities that are being heated, but also have large air leaks to the outdoors.

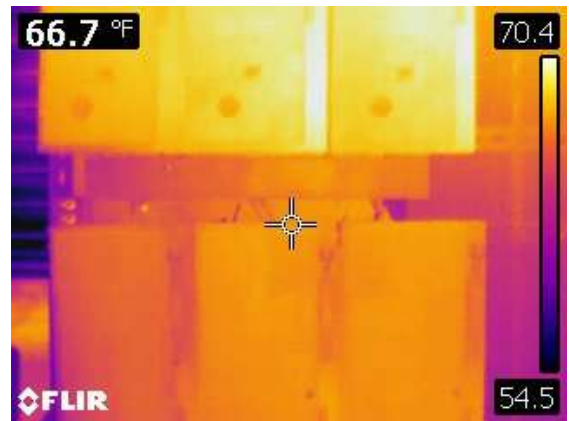
More electrical boxes that are well within the healthy temperature range.
